PHOTO INDEX

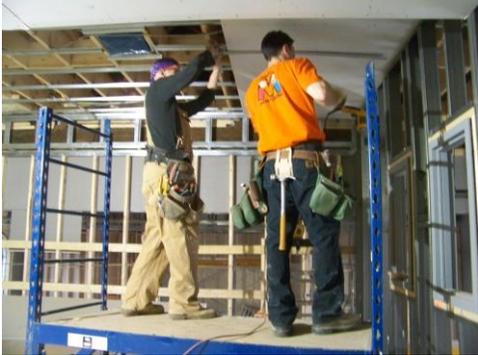
Photo showing carpenters installing GWB for the ceiling on the 2nd floor.

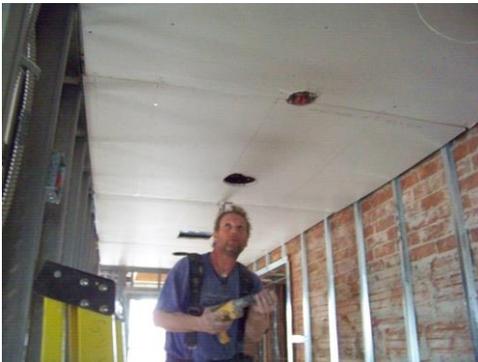
Photo showing carpenter installing GWB on the 2nd floor ceiling.

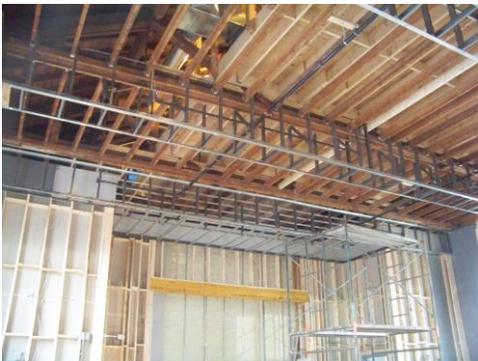
Photo meeting hall ceiling framing taking shape. This is looking at the west end of the meeting hall.

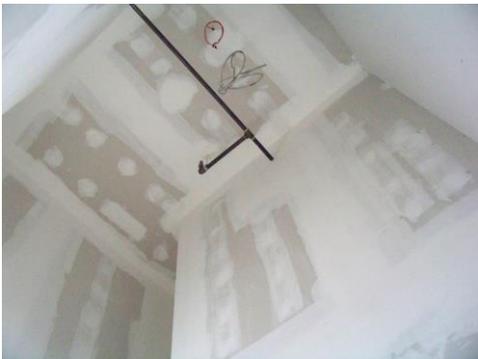
Photo showing the roughed in closet at the north end of the platform in the meeting hall.

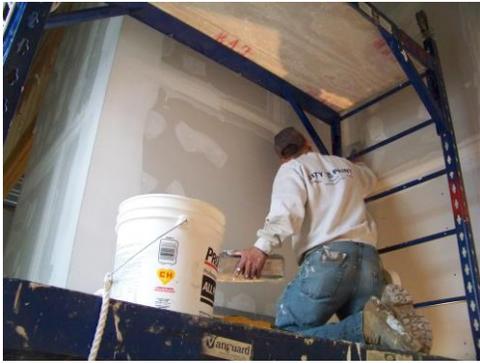
Photo showing plasterer working in the storage room at the south end of the platform in the meeting hall.

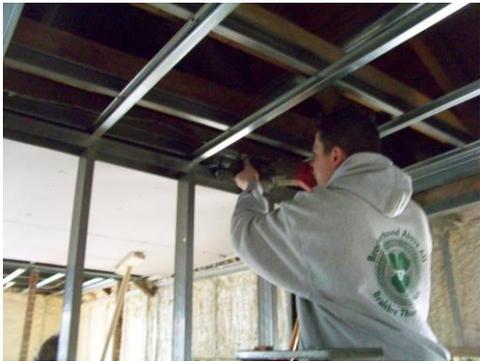
Photo showing HVAC workman making room for control wiring.

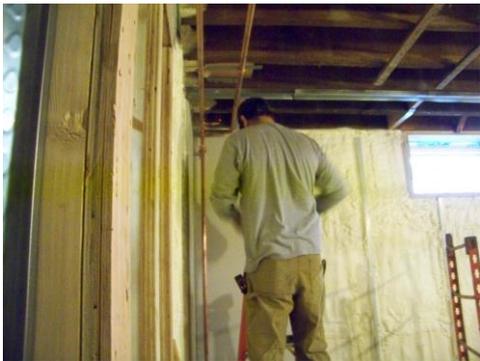
Photo showing HVAC mechanic installing control wiring in the basement.

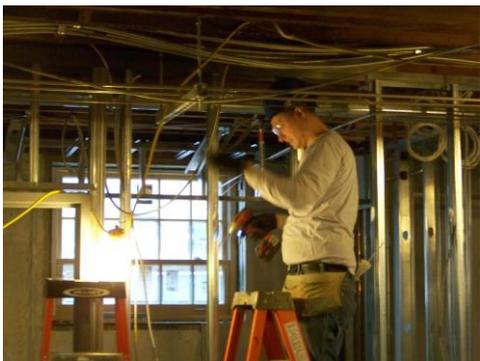
Photo showing electrician continuing with the wiring installation.

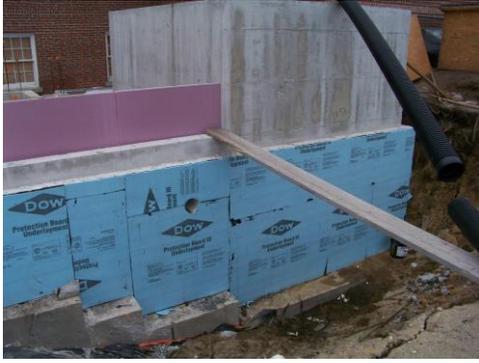
Photo showing foundation wall with waterproofing and protection board (blue) installed, and insulation installed (pink).

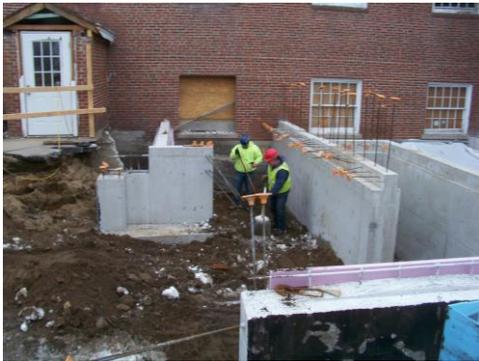
Photo showing workmen prepping the soil to get ready for compacting.

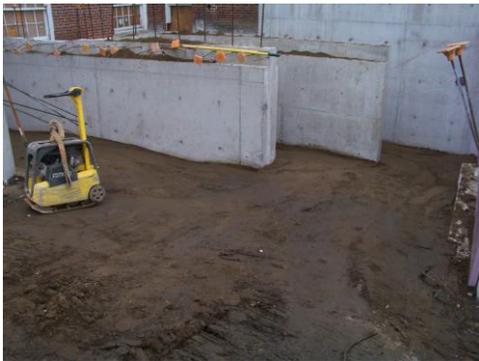
Photo showing the compaction machine and the area after being compacted.

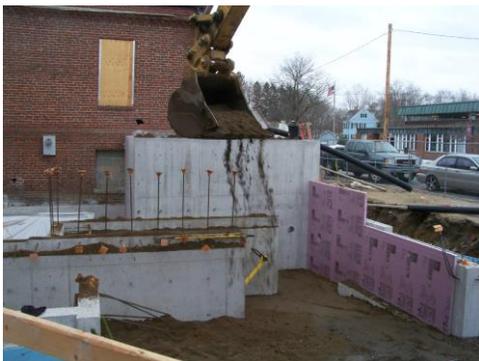
Photo showing soil being dumped for backfilling.
